Product Name: **BOV Kompact Hyundai i30N**  
Product Description: BOV Kompact Hyundai i30N  
Product Number: TS-0203-1036  
Document Version: V1.00 Rev A

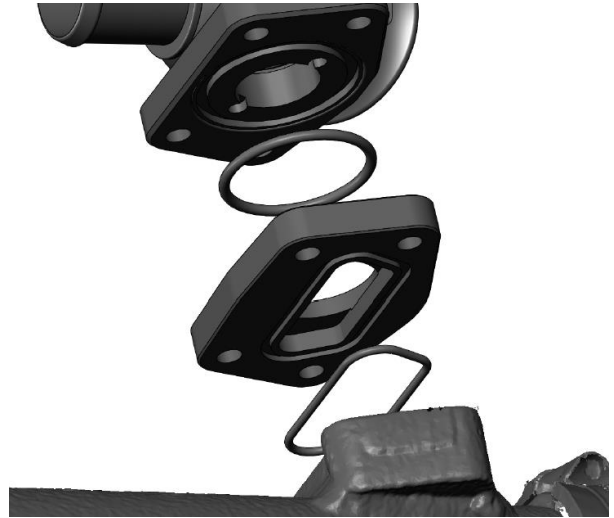
Take note of the orientation of the adapter plate with the trapezoid passage to be placed against the matching port on the charge pipe and the circle port to be against the BOV. Ensure O-rings are in place and fit together with the four supplied bolts.
